ASHFORD, CONNECTICUT

ASHFORD LAKE DAM
CT 00462

PHASE I INSPECTION REPORT
NATIONAL DAM INSPECTION PROGRAM

AUGUST 1980

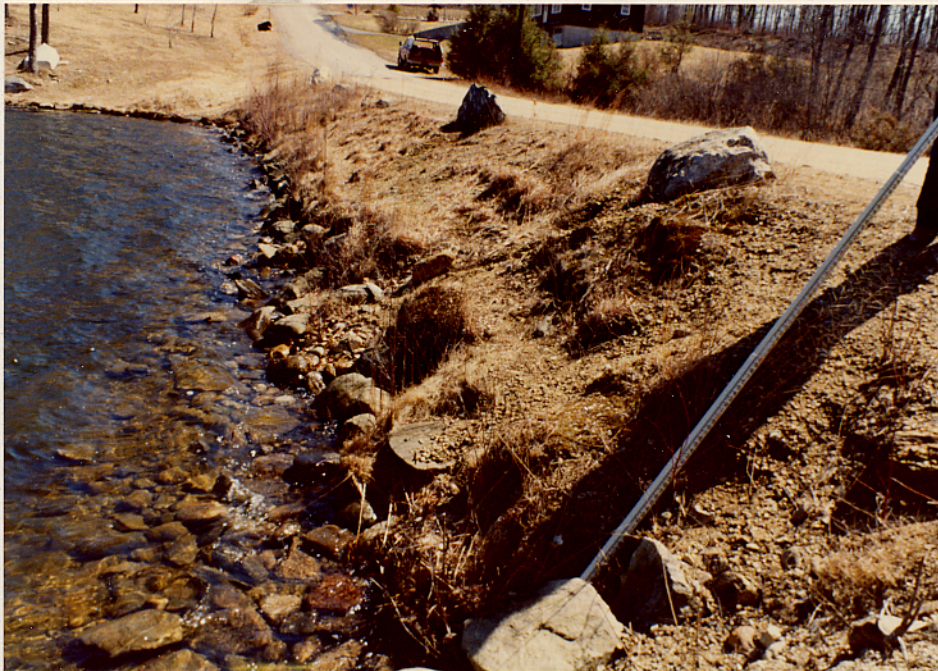
Upstream Slope - The upstream slope has dumped riprap to within 3+ feet of the crest. The strip between the riprap and the top of the dam is covered with weeds and brush, and has several areas eroded by trespassing (Photo 1). Several areas along the water had missing riprap, causing this part of the slope to be quite irregular (Photo 1).

Photo 1 - Erosion and riprap on upstream slope of dam taken from gate structure (March 1980).

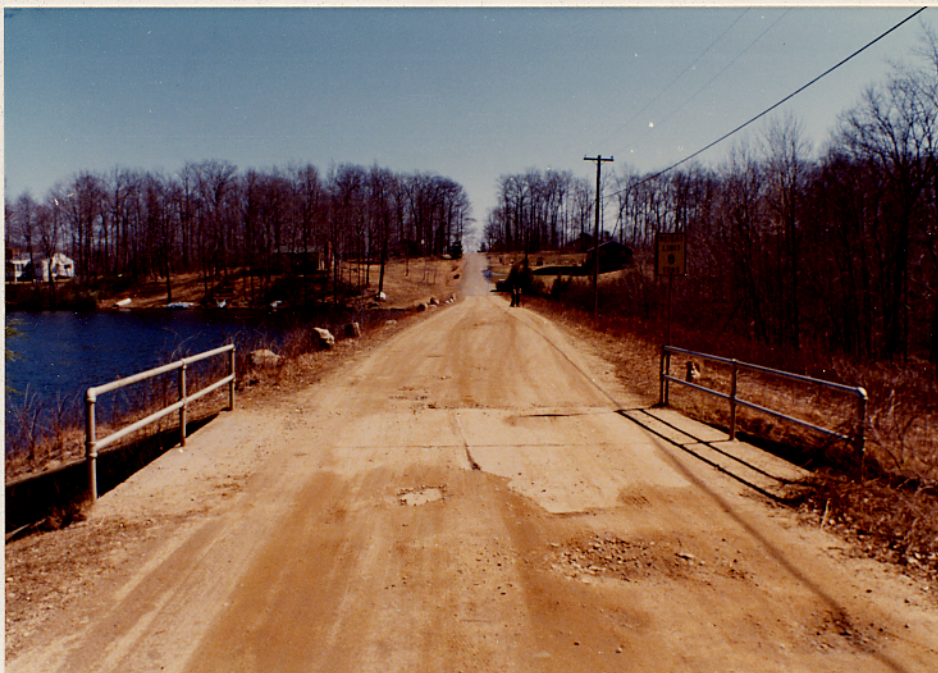
Crest - The top of the dam showed no signs of misalignment or visible cracking. However, there is an unpaved, two lane road which extends the length of the dam. This road had a number of pot holes and ruts (Photo 2).

Photo 2 - Unpaved road and potholes on top of dam taken from right abutment (March 1980).

5. The road on the top of the dam should be regraded and proper protection placed.
6. The spalled concrete of the valve chamber should be repaired.
7. All obstacles, debris, or overhanging trees and brush on the spillway crest, and the floor of the spillway approach, discharge and low-level outlet channels should be removed. The damaged earth dikes along the spillway discharge channel should be restored to prevent spillway discharge along the toe of the dam.

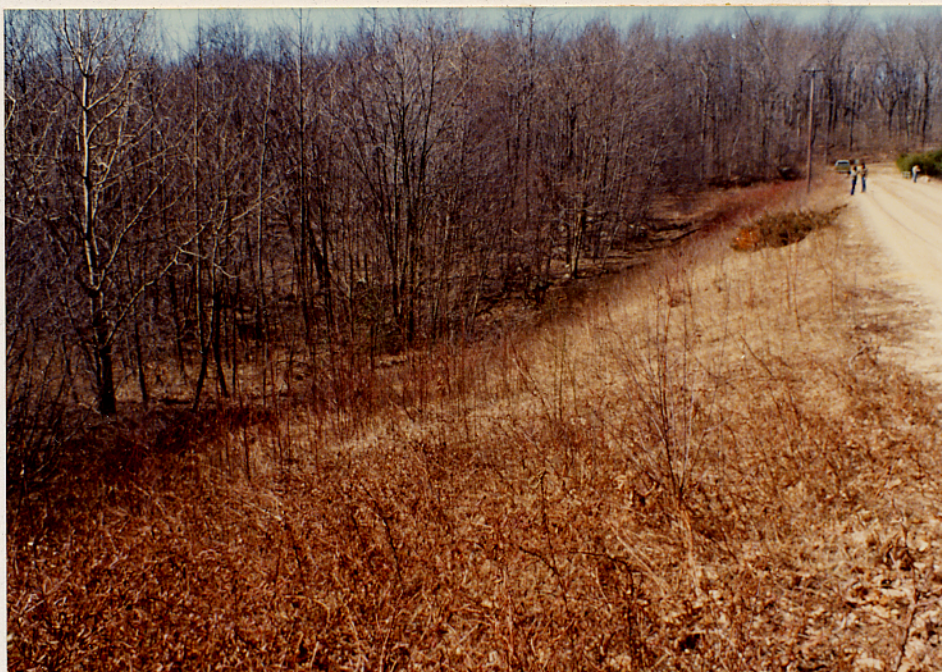
Downstream Slope - The downstream slope shows no signs of misalignment or sloughing. The entire slope is covered with weeds and brush (Photo 3). A seep of 2-3 gpm was observed at the left side of the toe of the dam. Water from this seep was clear. A small depression was noted approximately 6 feet below the top of the slope, 15+ feet right from the outlet headwall. This depression is approximately 6 feet long and 1 foot deep.

Photo 3 - Downstream slope of dam from left abutment
(March 1980).

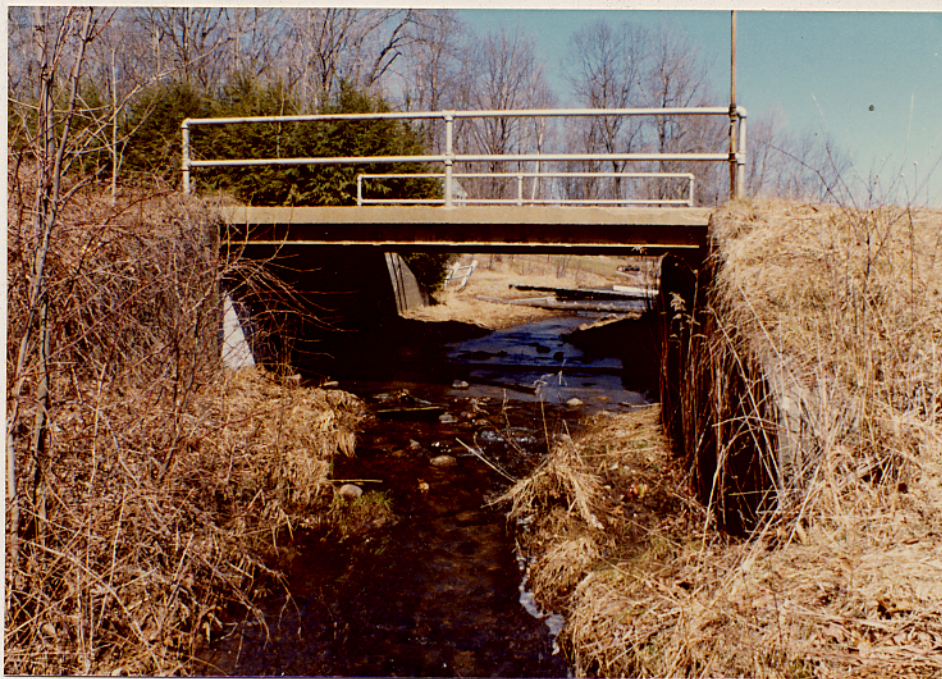
Photo 4 - Spillway channel taken from downstream
(March 1980).

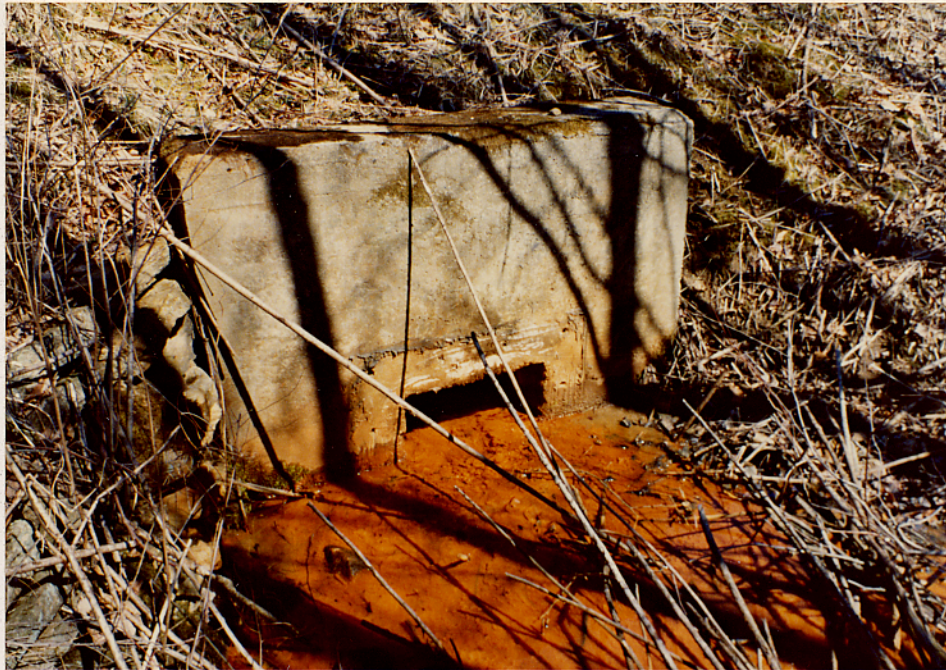
c. Appurtenant Structures - The concrete valve chamber for the low-level outlet had some spalling on the top surface and showed signs of settlement at the upstream side; however, no sign of cracking was observed on the exterior surface. The interior walls could not be inspected. The size, type and length of the outlet conduit could not be observed. The outlet headwall had no spalling and appeared to be in good condition (Photo 5). A flow of 4-6 gpm was observed coming from the outlet in the headwall. The dry-laid retaining wall at the right side of the outlet channel is in poor condition. The outlet channel itself is fairly wide and is filled with some debris and brush. The channel is also filled with orange-brown deposits, which seriously restrict flow from the outlet (Photo 5).

Photo 5 - Low-level outlet structure taken from discharge channel (March 1980).

8. The gate valve for the low-level outlet should be opened at least once a year to check its condition and to flush the outlet pipe. The valve should also be greased at this time.

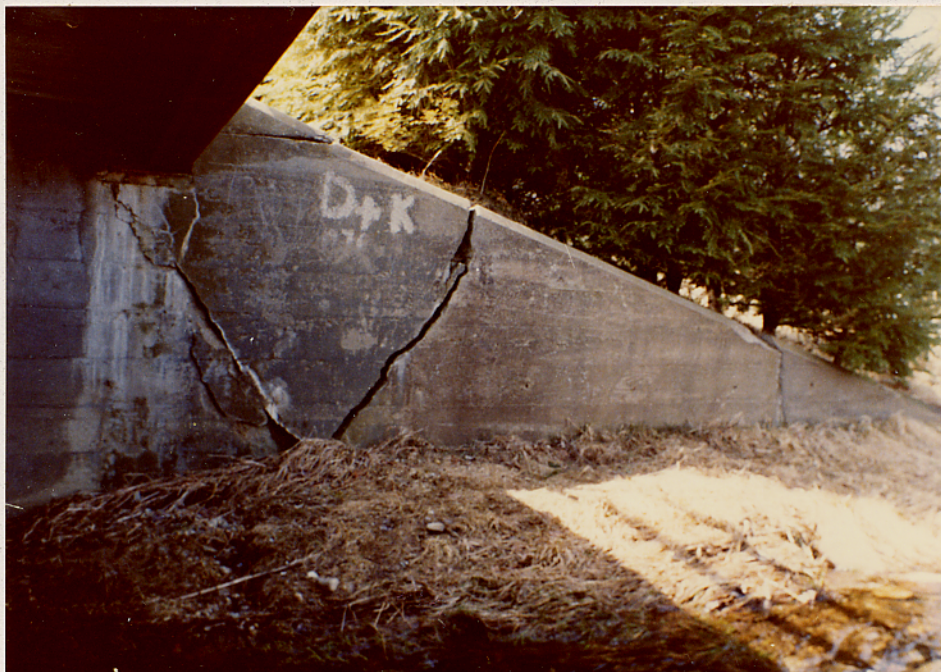
Spillway - The spillway is an unlined channel with a narrow-crested concrete weir. The left and right concrete abutment walls had several large cracks with horizontal displacement (toward channel) along these cracks (Photo 6). A log and some wood debris was observed in the approach channel (Photo 4). The discharge channel had some small overhanging trees and a small earth dike on each side of the channel just downstream from the dam.

Photo 6 - Cracking of right spillway abutment wall (upstream) taken from spillway channel (March 1980).

1. Repair of the concrete abutment walls at the spillway (Photo 6).
2. The significance of the depression area on the downstream slope in the central portion of the embankment and settlement of the valve chamber on the upstream slope.
3. Origin and significance of seepage at the toe of the dam near the outlet channel and at the left abutment. Development of a program to reduce or stop seepage through the embankment, if required.
4. Further inspection to determine the condition of the upstream gate valve and inside of the valve chamber.
5. Further inspection to determine the condition of the low-level outlet. This can be done by closing the valve at the upstream end and observing the outlet for seepage.
